UNDERGROUND STORAGE TANK CLOSURE REPORT

**BALBOA PACIFIC
11240 BLOOMFIELD AVENUE
SANTA FE SPRINGS, CALIFORNIA**

AUGUST, 1997

TRG Number 5033-BC

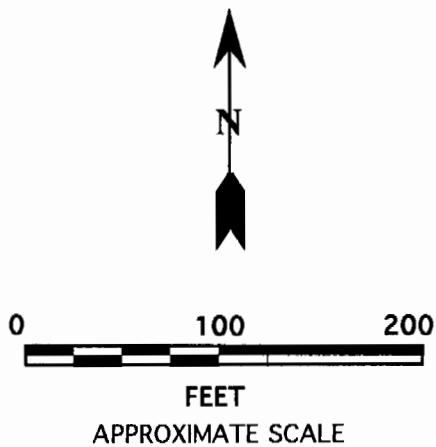
FIGURE 2
SITE PLOT PLAN WITH
SAMPLE LOCATION

The Site is currently occupied by Balboa Pacific, a contracting and environmental remediation company. The former 280 gallon UST was located on the northern central part of the property behind a storage garage. (See Figure 2).

After the UST was removed, a representative from The Reynolds Group collected one soil sample from beneath the former UST (Sample T-1). Inspector Nelson selected the sample location and observed the sample collection (See Figure 2).
